BUILT HERITAGE

REMOVING IVY FROM SIMPLE GRAVESTONES

SITE: Ramsey St Mary's Churchyard
Ramsey
Cambridgeshire

AIM: To investigate the effects of ivy on simple gravestones with no joints, and to trial ways of removing it.

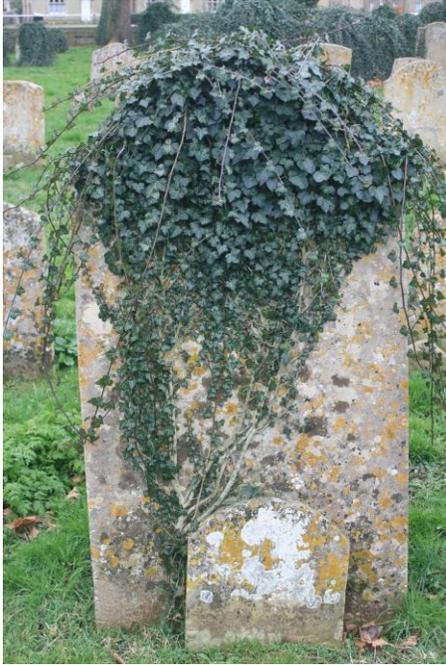
Juvenile

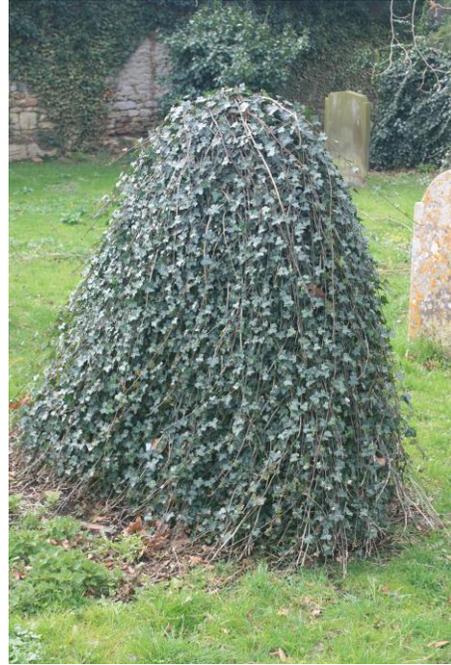
Shroud

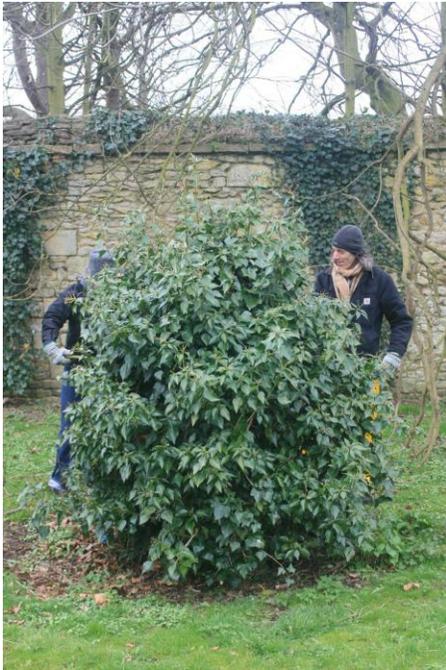
Shrub

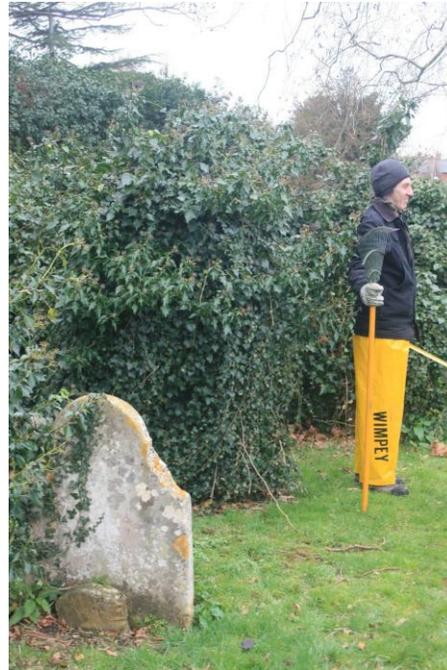
Shrub & Shroud

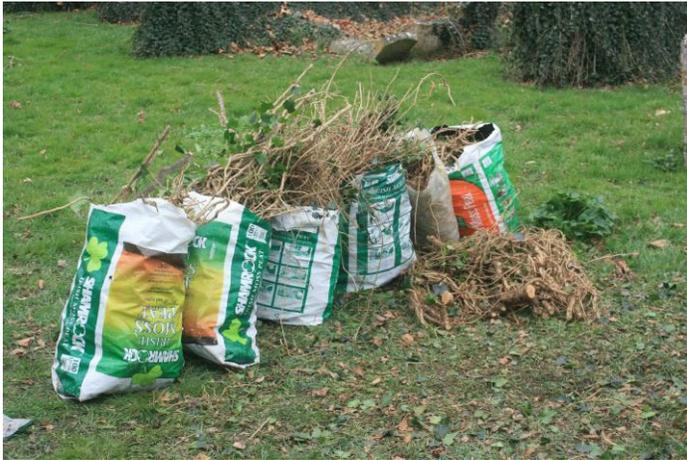
Step 5:

Prepare for a lot of waste!

Each gravestone produced over six sacks of ivy.

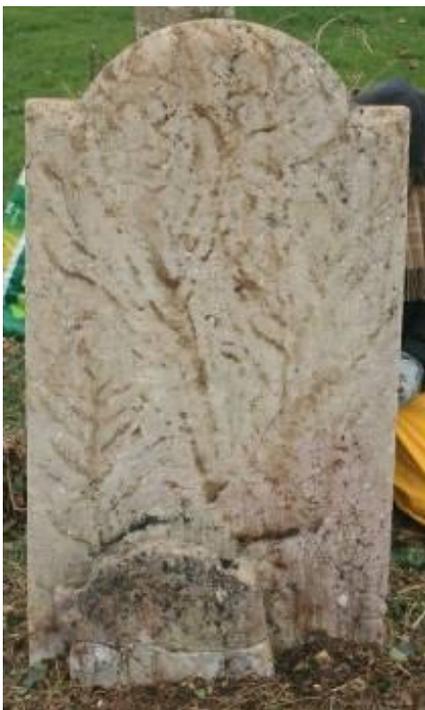
There was some staining on the stones following ivy removal. This was caused by either:

- The ivy roots keeping part of the stone clean whilst the rest has a layer of dirt
- Organic matter building up above each ivy stem and colouring the stone.

This staining may well disappear after a few years of exposure to the elements
